# Uniform Mitigation Verification Inspection Form

| Inspection Date: 05/17/2025 | | |
| Owner Name: Pinewood Village Bldg.10 | | Contact Person: |
| Address: 601 N. Hercules Ave | | Home Phone: |

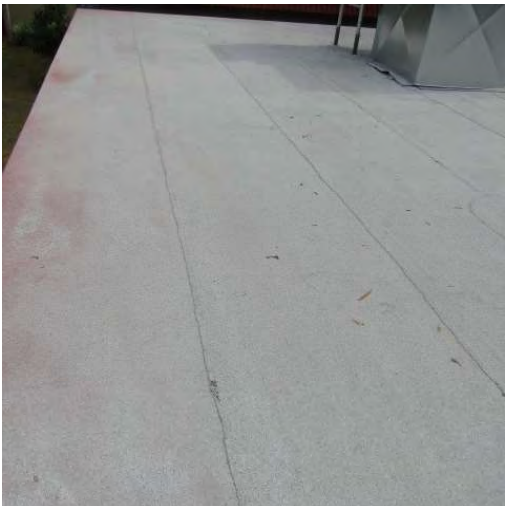
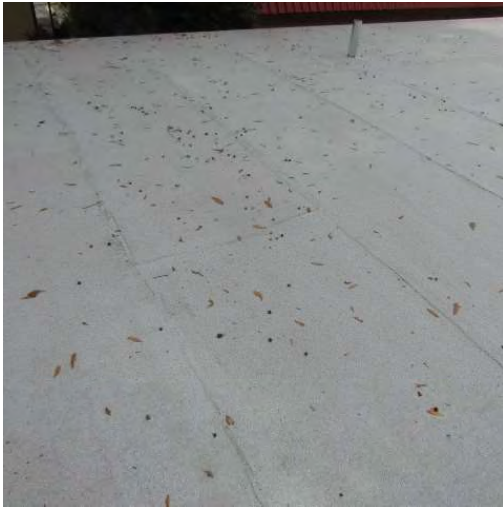
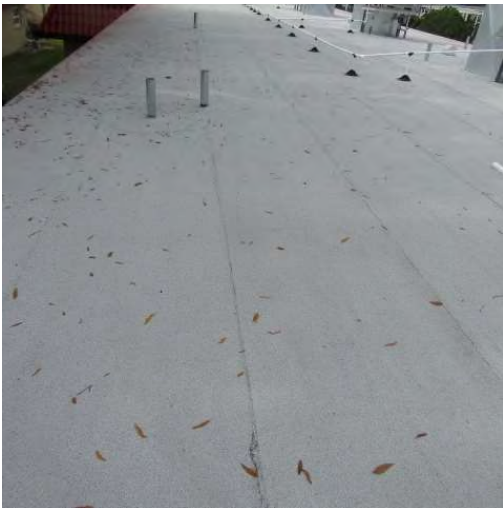
| 2.1 Roof Covering Type: | Permit Application Date | FBC or MDC Product Approval # | Year of Original Installation or Replacement | No Information Provided for Compliance |
|---|---|---|---|---|
| <input checked="" type="checkbox"/> 5. Membrane | 11/28/2021 | | 2021 | <input type="checkbox"/> |

- ☐ A. Hip Roof      Hip roof with no other roof shapes greater than 10% of the total roof system perimeter.  
Total length of non-hip features: \_\_\_\_\_ feet; Total roof system perimeter: \_\_\_\_\_ feet
- ☒ B. Flat Roof      Roof on a building with 5 or more units where at least 90% of the main roof area has a roof slope of less than 2:12. Roof area with slope less than 2:12      sq ft; Total roof area      sq ft
- ☐ C. Other Roof      Any roof that does not qualify as either (A) or (B) above.

Roof - 1

Roof - 2

Roof - 3

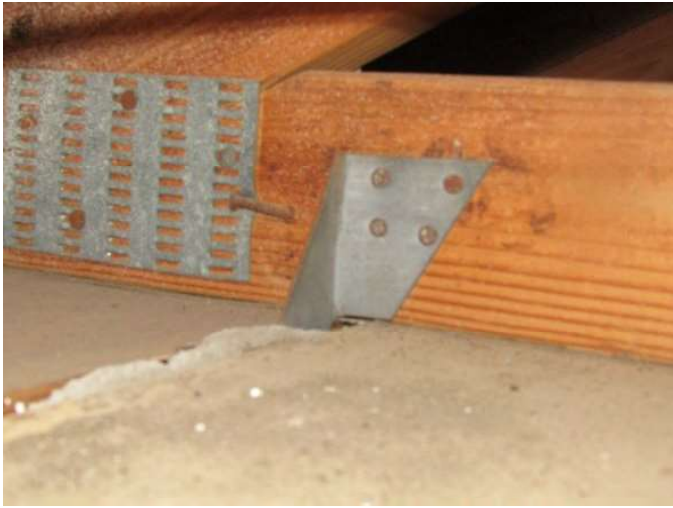
- ☒ Secured to truss/rafter with a minimum of three (3) nails, **and**
- ☒ Attached to the wall top plate of the wall framing, or embedded in the bond beam, with less than a 1/2" gap from the blocking or truss/rafter **and** blocked no more than 1.5" of the truss/rafter, **and** free of visible severe corrosion.
- ☒ B. Clips
  - ☒ Metal connectors that do not wrap over the top of the truss/rafter, **or**
  - ☐ Metal connectors with a minimum of 1 strap that wraps over the top of the truss/rafter and does not meet the nail position requirements of C or D, but is secured with a minimum of 3 nails.
- ☐ C. Single Wraps

Clip

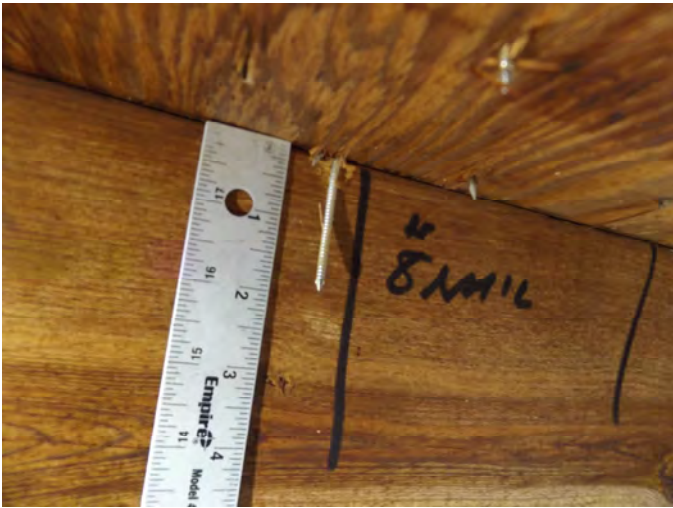
- ☒ C. Plywood/OSB roof sheathing with a minimum thickness of 7/16" inch attached to the roof truss/rafter (spaced a maximum of 24" inches o.c.) by 8d common nails spaced a maximum of 6" inches in the field. -OR- Dimensional lumber/Tongue & Groove decking with a minimum of 2 nails per board (or 1 nail per board if each board is equal to or less than 6 inches in width). -OR-

Nail length

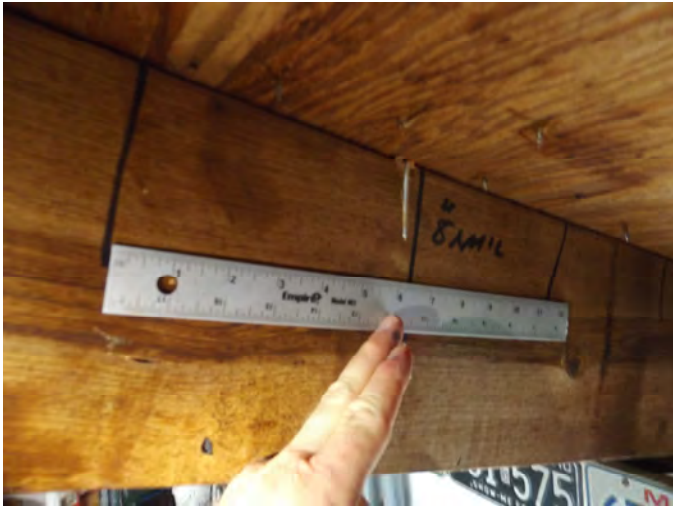
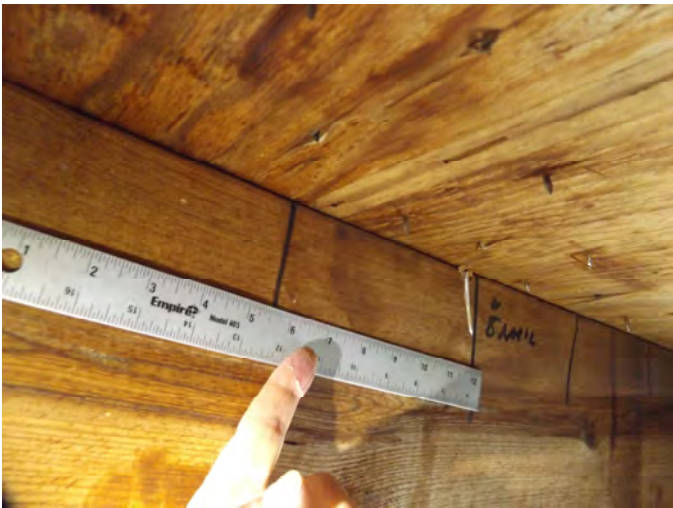
Nail spacing - 1

Nail spacing - 2

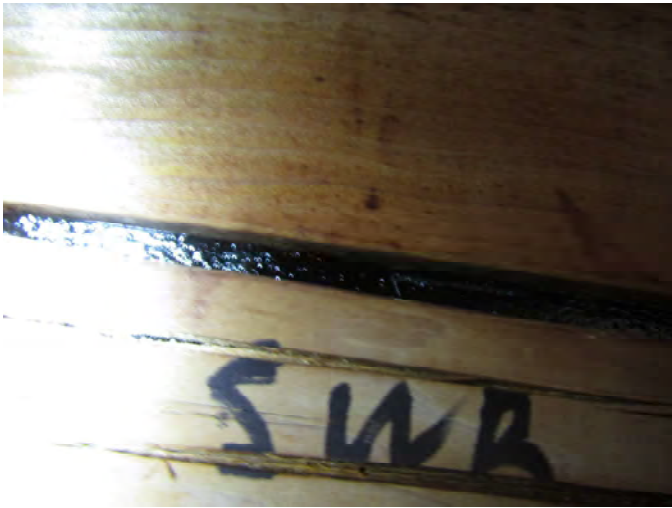
- ☒ A. SWR (also called Sealed Roof Deck) Self-adhering polymer modified-bitumen roofing underlayment applied directly to the sheathing or foam adhesive SWR barrier (not foamed-on insulation) applied as a supplemental means to protect the dwelling from water intrusion in the event of roof covering loss.
- ☐ B. No SWR.
- ☐ C. Unknown or undetermined.

SWR
