# Uniform Mitigation Verification Inspection Form

| Inspection Date: 05/17/2025 | | |
| Owner Name: Pinewood Villiage Bldg. 11 | | Contact Person: |
| Address: 601 N. Hercules Ave. | | Home Phone: |

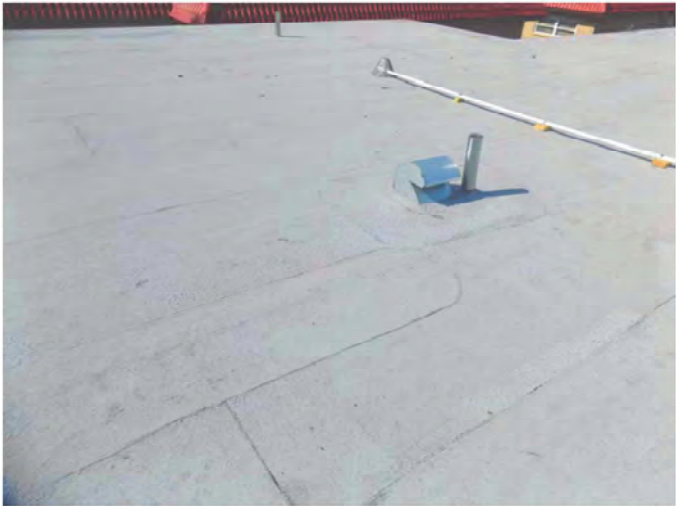
Roof - 1

| 2.1 Roof Covering Type: | Permit Application Date | FBC or MDC Product Approval # | Year of Original Installation or Replacement | No Information Provided for Compliance |
|---|---|---|---|---|
| <input checked="" type="checkbox"/> 5. Membrane | 02/18/2021 | | 2021 | <input type="checkbox"/> |

- ☐ A. Hip Roof      Hip roof with no other roof shapes greater than 10% of the total roof system perimeter.  
Total length of non-hip features: \_\_\_\_\_ feet; Total roof system perimeter: \_\_\_\_\_ feet
- ☒ B. Flat Roof      Roof on a building with 5 or more units where at least 90% of the main roof area has a roof slope of less than 2:12. Roof area with slope less than 2:12 \_\_\_\_\_ sq ft; Total roof area \_\_\_\_\_ sq ft
- ☐ C. Other Roof      Any roof that does not qualify as either (A) or (B) above.

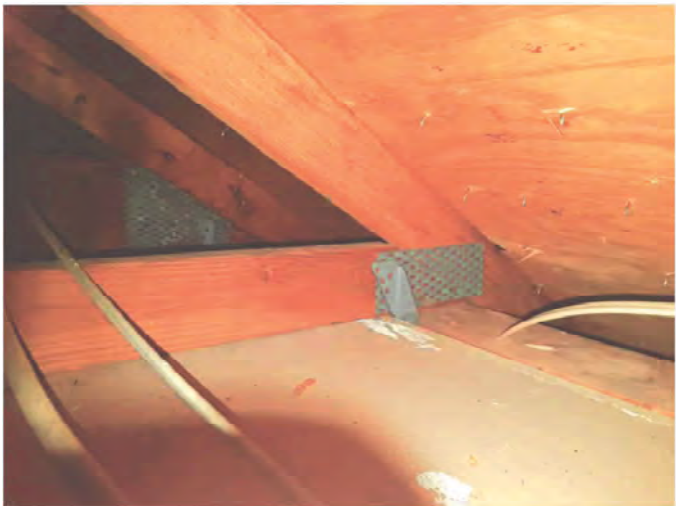
Clip

- ☒ Secured to truss/rafter with a minimum of three (3) nails, **and**
- ☒ Attached to the wall top plate of the wall framing, or embedded in the bond beam, with less than a 1/2" gap from the blocking or truss/rafter **and** blocked no more than 1.5" of the truss/rafter, **and** free of visible severe corrosion.
- ☒ B. Clips
  - ☒ Metal connectors that do not wrap over the top of the truss/rafter, **or**
  - ☐ Metal connectors with a minimum of 1 strap that wraps over the top of the truss/rafter and does not meet the nail position requirements of C or D, but is secured with a minimum of 3 nails.
- ☐ C. Single Wraps

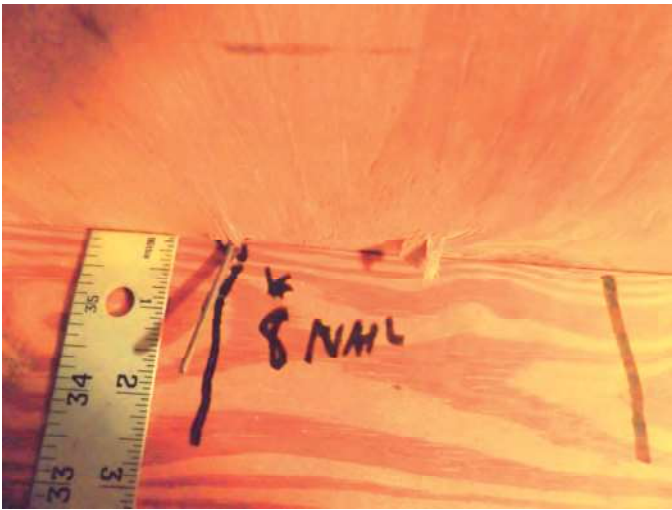
Nail Length

- ☒ C. Plywood/OSB roof sheathing with a minimum thickness of 7/16" inch attached to the roof truss/rafter (spaced a maximum of 24" inches o.c.) by 8d common nails spaced a maximum of 6" inches in the field. -OR- Dimensional lumber/Tongue & Groove decking with a minimum of 2 nails per board (or 1 nail per board if each board is equal to or less than 6 inches in width). -OR-

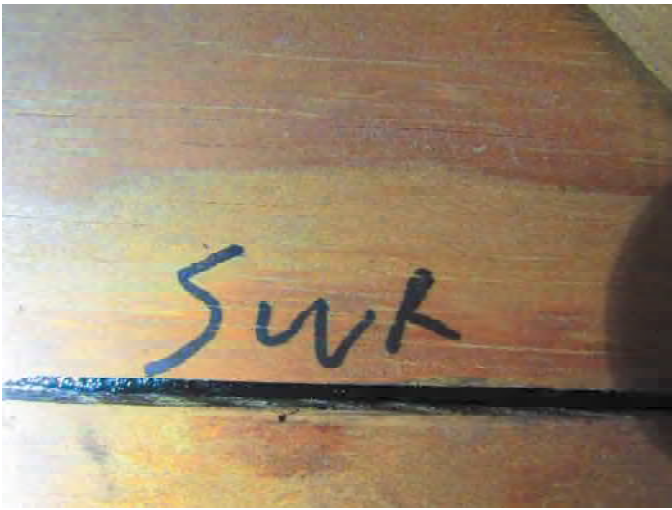
- ☒ A. SWR (also called Sealed Roof Deck) Self-adhering polymer modified-bitumen roofing underlayment applied directly to the sheathing or foam adhesive SWR barrier (not foamed-on insulation) applied as a supplemental means to protect the dwelling from water intrusion in the event of roof covering loss.
- ☐ B. No SWR.
- ☐ C. Unknown or undetermined.
