# Uniform Mitigation Verification Inspection Form

| Inspection Date: 05/15/2025 | | |
| Owner Name: Pinewood Village Bldg. 12 | | Contact Person: |
| Address: 601 N. Hercules Ave | | Home Phone: |

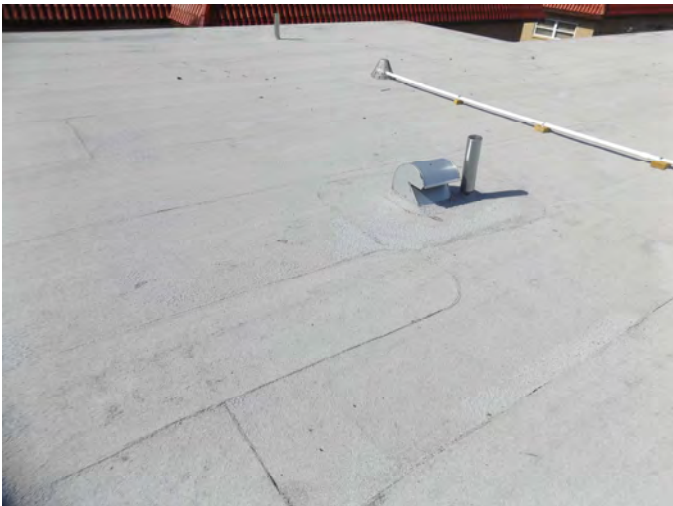
Roof - 1

| 2.1 Roof Covering Type: | Permit Application Date | FBC or MDC Product Approval # | Year of Original Installation or Replacement | No Information Provided for Compliance |
|---|---|---|---|---|
| <input checked="" type="checkbox"/> 5. Membrane | 03/16/2021 | | 2021 | <input type="checkbox"/> |

- ☐ A. Hip Roof      Hip roof with no other roof shapes greater than 10% of the total roof system perimeter.  
Total length of non-hip features: \_\_\_\_\_ feet; Total roof system perimeter: \_\_\_\_\_ feet
- ☒ B. Flat Roof      Roof on a building with 5 or more units where at least 90% of the main roof area has a roof slope of less than 2:12. Roof area with slope less than 2:12      sq ft; Total roof area      sq ft
- ☐ C. Other Roof      Any roof that does not qualify as either (A) or (B) above.

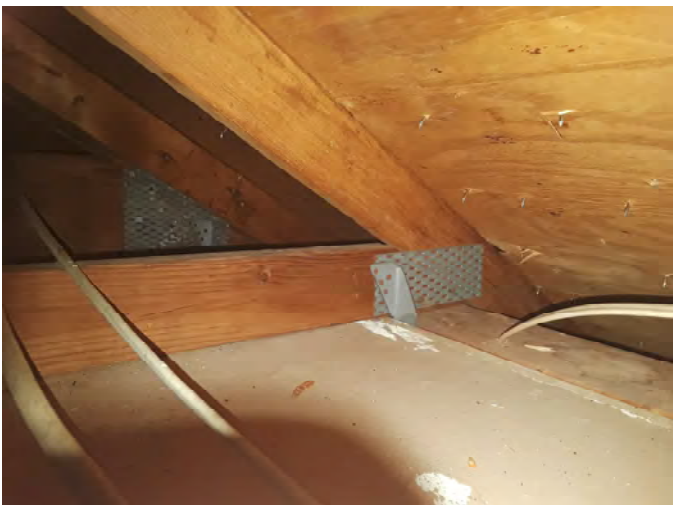
Clip

- ☒ Secured to truss/rafter with a minimum of three (3) nails, **and**
- ☒ Attached to the wall top plate of the wall framing, or embedded in the bond beam, with less than a 1/2" gap from the blocking or truss/rafter **and** blocked no more than 1.5" of the truss/rafter, **and** free of visible severe corrosion.
- ☒ B. Clips
  - ☒ Metal connectors that do not wrap over the top of the truss/rafter, **or**
  - ☐ Metal connectors with a minimum of 1 strap that wraps over the top of the truss/rafter and does not meet the nail position requirements of C or D, but is secured with a minimum of 3 nails.
- ☐ C. Single Wraps

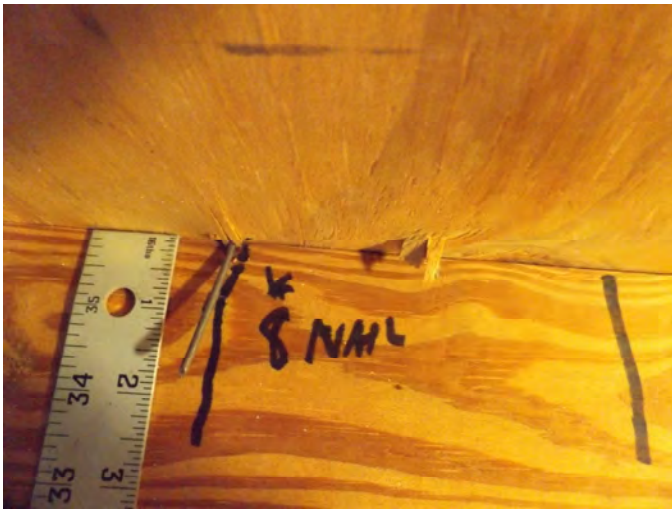
Nail Length

- ☒ C. Plywood/OSB roof sheathing with a minimum thickness of 7/16" inch attached to the roof truss/rafter (spaced a maximum of 24" inches o.c.) by 8d common nails spaced a maximum of 6" inches in the field. -OR- Dimensional lumber/Tongue & Groove decking with a minimum of 2 nails per board (or 1 nail per board if each board is equal to or less than 6 inches in width). -OR-
