# Uniform Mitigation Verification Inspection Form

| Inspection Date: 05/17/2025 | | |
| Owner Name: Pinewood Village Bldg. 13 | | Contact Person: |
| Address: 601 N. Hercules Ave | | Home Phone: |

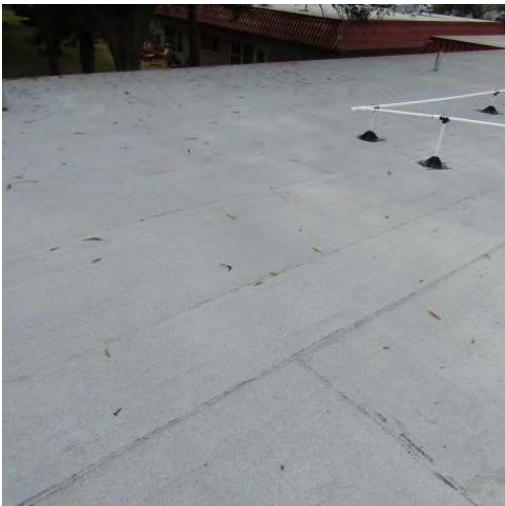
Roof - 1

| 2.1 Roof Covering Type: | Permit Application Date | FBC or MDC Product Approval # | Year of Original Installation or Replacement | No Information Provided for Compliance |
|---|---|---|---|---|
| <input checked="" type="checkbox"/> 5. Membrane | 11/28/2021 | | 2021 | <input type="checkbox"/> |

- ☐ A. Hip Roof      Hip roof with no other roof shapes greater than 10% of the total roof system perimeter.  
Total length of non-hip features: \_\_\_\_\_ feet; Total roof system perimeter: \_\_\_\_\_ feet
- ☒ B. Flat Roof      Roof on a building with 5 or more units where at least 90% of the main roof area has a roof slope of less than 2:12. Roof area with slope less than 2:12 \_\_\_\_\_ sq ft; Total roof area \_\_\_\_\_ sq ft
- ☐ C. Other Roof      Any roof that does not qualify as either (A) or (B) above.

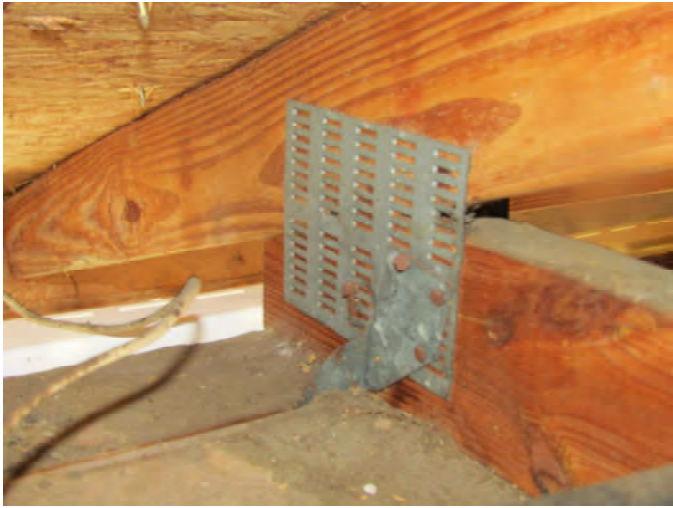
Clip

- ☒ Secured to truss/rafter with a minimum of three (3) nails, **and**
- ☒ Attached to the wall top plate of the wall framing, or embedded in the bond beam, with less than a 1/2" gap from the blocking or truss/rafter **and** blocked no more than 1.5" of the truss/rafter, **and** free of visible severe corrosion.
- ☒ B. Clips
  - ☒ Metal connectors that do not wrap over the top of the truss/rafter, **or**
  - ☐ Metal connectors with a minimum of 1 strap that wraps over the top of the truss/rafter and does not meet the nail position requirements of C or D, but is secured with a minimum of 3 nails.
- ☐ C. Single Wraps

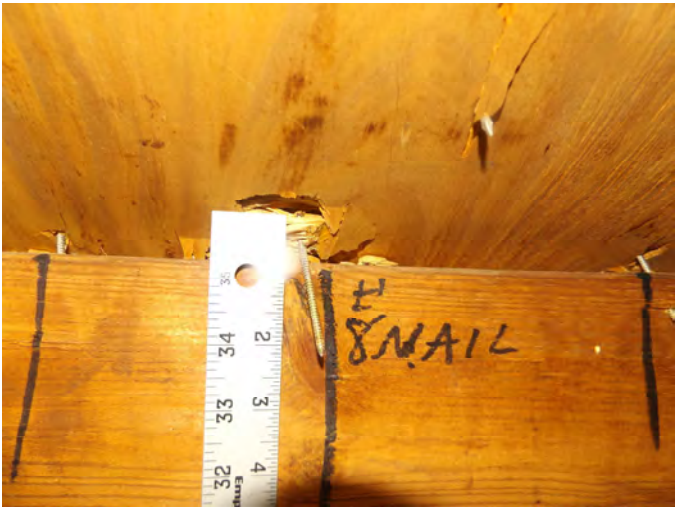
Nail length

☒ C. Plywood/OSB roof sheathing with a minimum thickness of 7/16" inch attached to the roof truss/rafter (spaced a maximum of 24" inches o.c.) by 8d common nails spaced a maximum of 6" inches in the field. -OR- Dimensional lumber/Tongue & Groove decking with a minimum of 2 nails per board (or 1 nail per board if each board is equal to or less than 6 inches in width). -OR-
