Uniform Mitigation Verification Inspection Form

| Inspection Date: 07/12/2021 | | |
| Owner Name: Pinewood Village Bldg. # 1401-1406 | | Contact Person: |
| Address: 601 N. Hercules Ave | | Home Phone: |

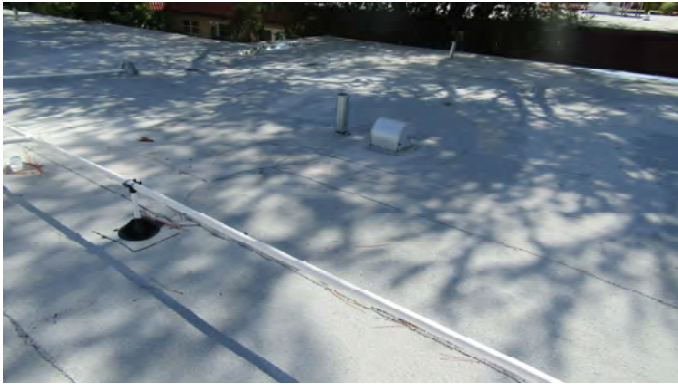
Roof - 1

- ☐ A. Hip Roof Hip roof with no other roof shapes greater than 10% of the total roof system perimeter.
Total length of non-hip features: _____ feet; Total roof system perimeter: _____ feet
- ☒ B. Flat Roof Roof on a building with 5 or more units where at least 90% of the main roof area has a roof slope of less than 2:12. Roof area with slope less than 2:12 sq ft; Total roof area sq ft
- ☐ C. Other Roof Any roof that does not qualify as either (A) or (B) above.

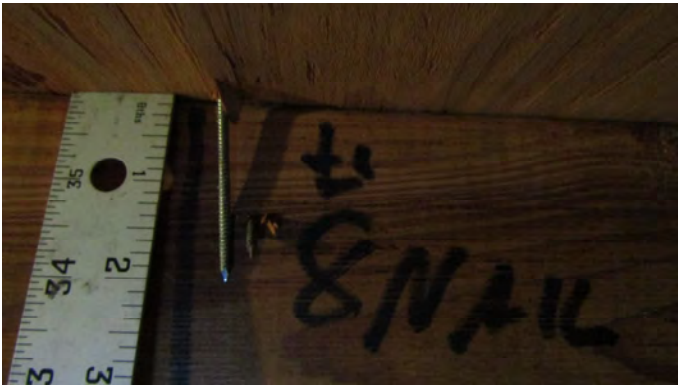
Nail length

- ☒ C. Plywood/OSB roof sheathing with a minimum thickness of 7/16" inch attached to the roof truss/rafter (spaced a maximum of 24" inches o.c.) by 8d common nails spaced a maximum of 6" inches in the field. -OR- Dimensional lumber/Tongue & Groove decking with a minimum of 2 nails per board (or 1 nail per board if each board is equal to or less than 6 inches in width). -OR-
