# Uniform Mitigation Verification Inspection Form

| Inspection Date: 05/15/2025 | | |
| Owner Name: Pinewood Village Bldg. 14 | | Contact Person: |
| Address: 601 N. Hercules Ave | | Home Phone: |

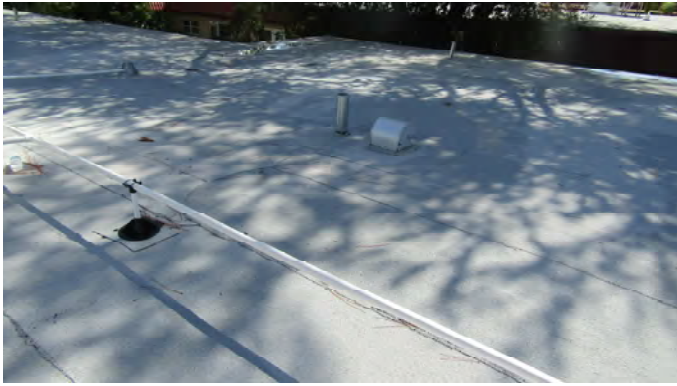
Roof - 1

| 2.1 Roof Covering Type: | Permit Application Date | FBC or MDC Product Approval # | Year of Original Installation or Replacement | No Information Provided for Compliance |
|---|---|---|---|---|
| <input checked="" type="checkbox"/> 5. Membrane | 04/21/2021 | | 2021 | <input type="checkbox"/> |

- ☐ A. Hip Roof      Hip roof with no other roof shapes greater than 10% of the total roof system perimeter.  
Total length of non-hip features: \_\_\_\_\_ feet; Total roof system perimeter: \_\_\_\_\_ feet
- ☒ B. Flat Roof      Roof on a building with 5 or more units where at least 90% of the main roof area has a roof slope of less than 2:12. Roof area with slope less than 2:12      sq ft; Total roof area      sq ft
- ☐ C. Other Roof      Any roof that does not qualify as either (A) or (B) above.

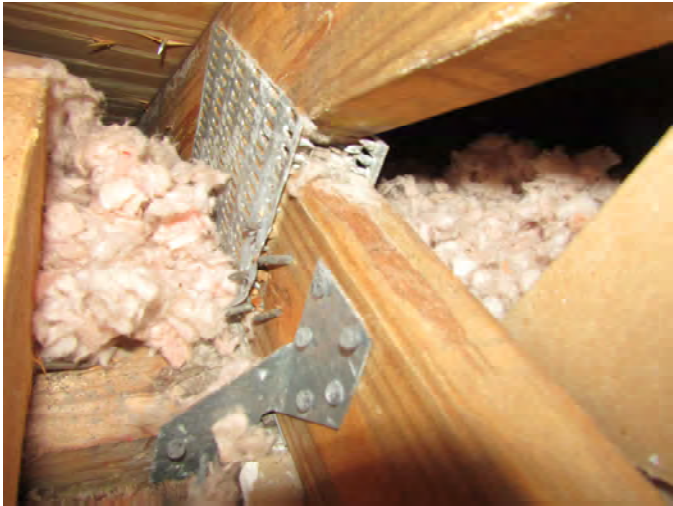
Clip

- ☒ Secured to truss/rafter with a minimum of three (3) nails, **and**
- ☒ Attached to the wall top plate of the wall framing, or embedded in the bond beam, with less than a 1/2" gap from the blocking or truss/rafter **and** blocked no more than 1.5" of the truss/rafter, **and** free of visible severe corrosion.
- ☒ B. Clips
  - ☒ Metal connectors that do not wrap over the top of the truss/rafter, **or**
  - ☐ Metal connectors with a minimum of 1 strap that wraps over the top of the truss/rafter and does not meet the nail position requirements of C or D, but is secured with a minimum of 3 nails.
- ☐ C. Single Wraps

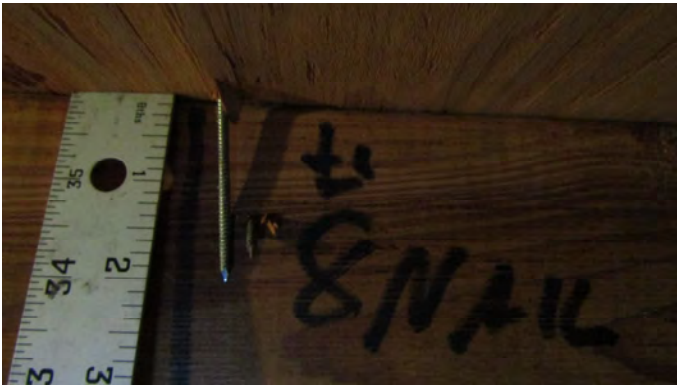
Nail length

- ☒ C. Plywood/OSB roof sheathing with a minimum thickness of 7/16" inch attached to the roof truss/rafter (spaced a maximum of 24" inches o.c.) by 8d common nails spaced a maximum of 6" inches in the field. -OR- Dimensional lumber/Tongue & Groove decking with a minimum of 2 nails per board (or 1 nail per board if each board is equal to or less than 6 inches in width). -OR-
