# Uniform Mitigation Verification Inspection Form

| Inspection Date: 05/15/2025 | | |
| Owner Name: Pinewood Village Bldg. 15 | | Contact Person: |
| Address: 601 N. Hercules Ave | | Home Phone: |

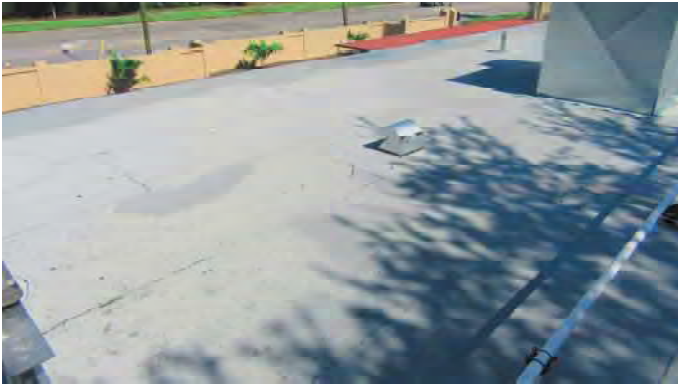
Roof - 1

| 2.1 Roof Covering Type: | Permit Application Date | FBC or MDC Product Approval # | Year of Original Installation or Replacement | No Information Provided for Compliance |
|---|---|---|---|---|
| <input checked="" type="checkbox"/> 5. Membrane | 04/28/2021 | | 2021 | <input type="checkbox"/> |

- ☐ A. Hip Roof      Hip roof with no other roof shapes greater than 10% of the total roof system perimeter.  
Total length of non-hip features: \_\_\_\_\_ feet; Total roof system perimeter: \_\_\_\_\_ feet
- ☒ B. Flat Roof      Roof on a building with 5 or more units where at least 90% of the main roof area has a roof slope of less than 2:12. Roof area with slope less than 2:12      sq ft; Total roof area      sq ft
- ☐ C. Other Roof      Any roof that does not qualify as either (A) or (B) above.

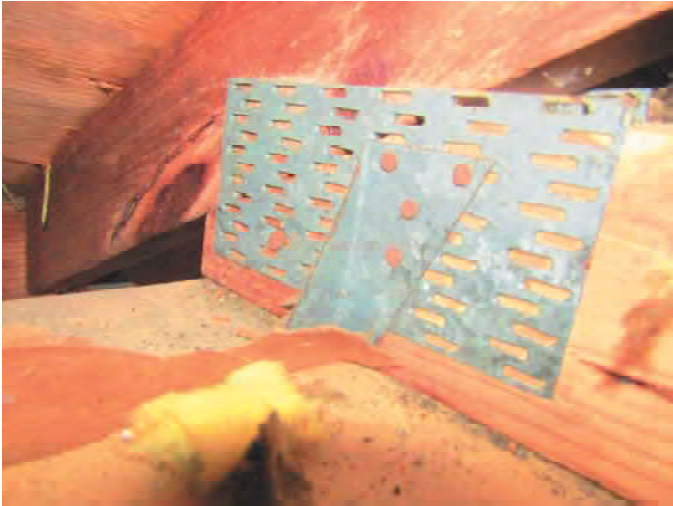
Clip

- ☒ Secured to truss/rafter with a minimum of three (3) nails, **and**
- ☒ Attached to the wall top plate of the wall framing, or embedded in the bond beam, with less than a 1/2" gap from the blocking or truss/rafter **and** blocked no more than 1.5" of the truss/rafter, **and** free of visible severe corrosion.
- ☒ B. Clips
  - ☒ Metal connectors that do not wrap over the top of the truss/rafter, **or**
  - ☐ Metal connectors with a minimum of 1 strap that wraps over the top of the truss/rafter and does not meet the nail position requirements of C or D, but is secured with a minimum of 3 nails.
- ☐ C. Single Wraps

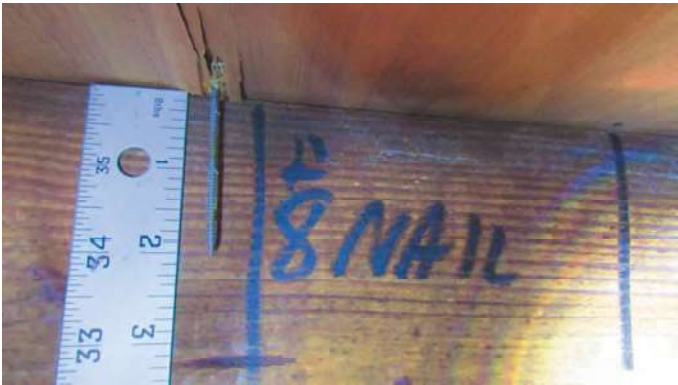
Nail length

- ☒ C. Plywood/OSB roof sheathing with a minimum thickness of 7/16" inch attached to the roof truss/rafter (spaced a maximum of 24" inches o.c.) by 8d common nails spaced a maximum of 6" inches in the field. -OR- Dimensional lumber/Tongue & Groove decking with a minimum of 2 nails per board (or 1 nail per board if each board is equal to or less than 6 inches in width). -OR-

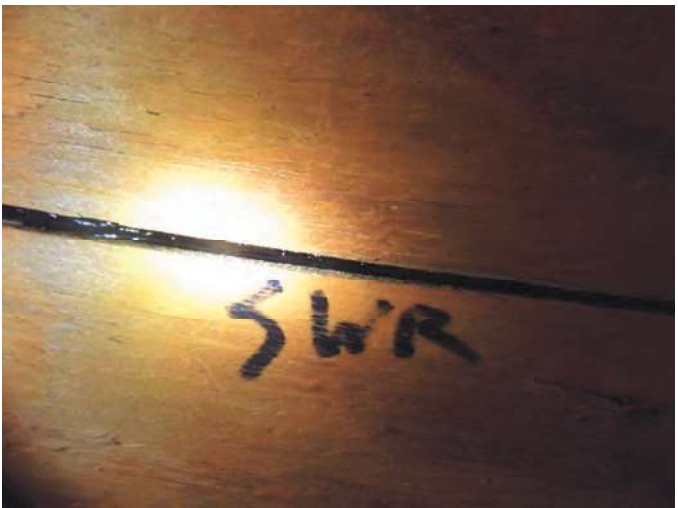
- ☒ A. SWR (also called Sealed Roof Deck) Self-adhering polymer modified-bitumen roofing underlayment applied directly to the sheathing or foam adhesive SWR barrier (not foamed-on insulation) applied as a supplemental means to protect the dwelling from water intrusion in the event of roof covering loss.
- ☐ B. No SWR.
- ☐ C. Unknown or undetermined.
