# Uniform Mitigation Verification Inspection Form

| Inspection Date: 05/15/2025 | | |
| Owner Name: Pinewood Village Bldg. 16 | | Contact Person: |
| Address: 601 N. Hercules Ave | | Home Phone: |

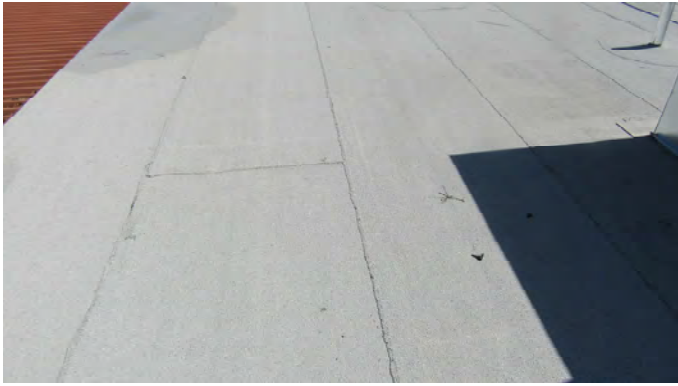
Roof - 1

| 2.1 Roof Covering Type: | Permit Application Date | FBC or MDC Product Approval # | Year of Original Installation or Replacement | No Information Provided for Compliance |
|---|---|---|---|---|
| <input checked="" type="checkbox"/> 5. Membrane | 04/28/2021 | | 2021 | <input type="checkbox"/> |

- ☐ A. Hip Roof      Hip roof with no other roof shapes greater than 10% of the total roof system perimeter.  
Total length of non-hip features: \_\_\_\_\_ feet; Total roof system perimeter: \_\_\_\_\_ feet
- ☒ B. Flat Roof      Roof on a building with 5 or more units where at least 90% of the main roof area has a roof slope of less than 2:12. Roof area with slope less than 2:12      sq ft; Total roof area      sq ft
- ☐ C. Other Roof      Any roof that does not qualify as either (A) or (B) above.

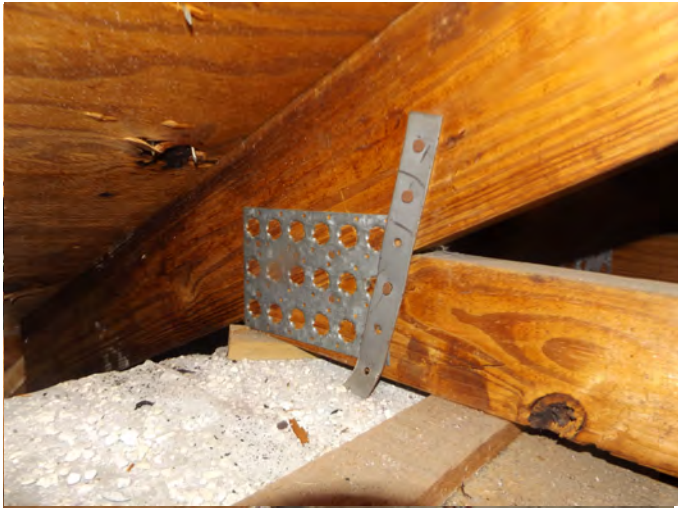
Clip

- ☒ Secured to truss/rafter with a minimum of three (3) nails, **and**
- ☒ Attached to the wall top plate of the wall framing, or embedded in the bond beam, with less than a 1/2" gap from the blocking or truss/rafter **and** blocked no more than 1.5" of the truss/rafter, **and** free of visible severe corrosion.
- ☒ B. Clips
  - ☒ Metal connectors that do not wrap over the top of the truss/rafter, **or**
  - ☐ Metal connectors with a minimum of 1 strap that wraps over the top of the truss/rafter and does not meet the nail position requirements of C or D, but is secured with a minimum of 3 nails.
- ☐ C. Single Wraps

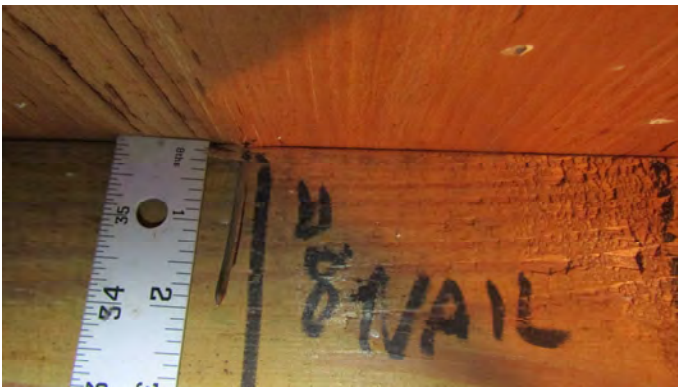
Nail length

- ☒ C. Plywood/OSB roof sheathing with a minimum thickness of 7/16" inch attached to the roof truss/rafter (spaced a maximum of 24" inches o.c.) by 8d common nails spaced a maximum of 6" inches in the field. -OR- Dimensional lumber/Tongue & Groove decking with a minimum of 2 nails per board (or 1 nail per board if each board is equal to or less than 6 inches in width). -OR-

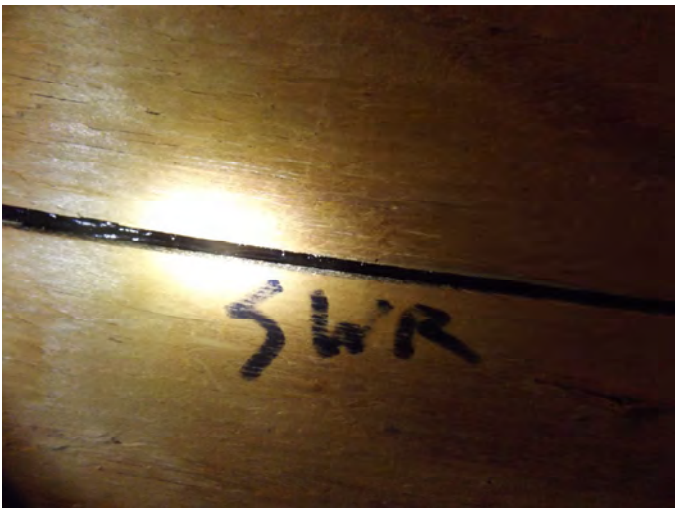
- ☒ A. SWR (also called Sealed Roof Deck) Self-adhering polymer modified-bitumen roofing underlayment applied directly to the sheathing or foam adhesive SWR barrier (not foamed-on insulation) applied as a supplemental means to protect the dwelling from water intrusion in the event of roof covering loss.
- ☐ B. No SWR.
- ☐ C. Unknown or undetermined.
