# Uniform Mitigation Verification Inspection Form

| Inspection Date: 05/15/2025 | | |
| Owner Name: Pinewood Village | | Contact Person: |
| Address: 601 No. Hercules Ave. Bldg. 2 | | Home Phone: |

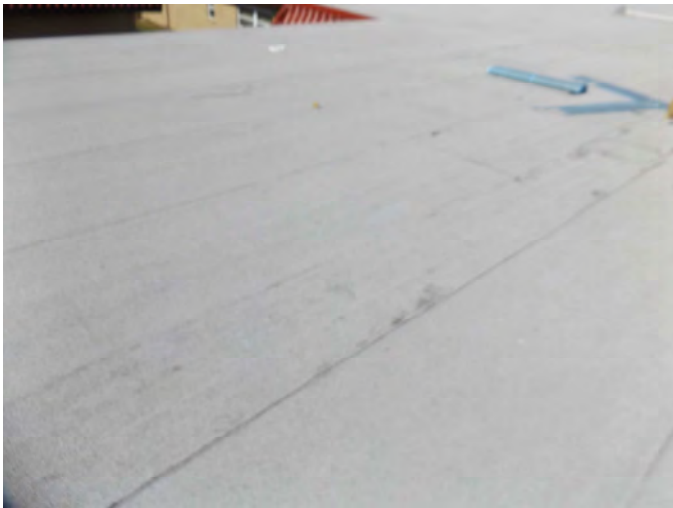
Roof - 1

| 2.1 Roof Covering Type: | Permit Application Date | FBC or MDC Product Approval # | Year of Original Installation or Replacement | No Information Provided for Compliance |
|---|---|---|---|---|
| <input checked="" type="checkbox"/> 5. Membrane | 03/16/2021 | | 2021 | <input type="checkbox"/> |

- ☐ A. Hip Roof      Hip roof with no other roof shapes greater than 10% of the total roof system perimeter.  
Total length of non-hip features: \_\_\_\_\_ feet; Total roof system perimeter: \_\_\_\_\_ feet
- ☒ B. Flat Roof      Roof on a building with 5 or more units where at least 90% of the main roof area has a roof slope of less than 2:12. Roof area with slope less than 2:12      sq ft; Total roof area      sq ft
- ☐ C. Other Roof      Any roof that does not qualify as either (A) or (B) above.

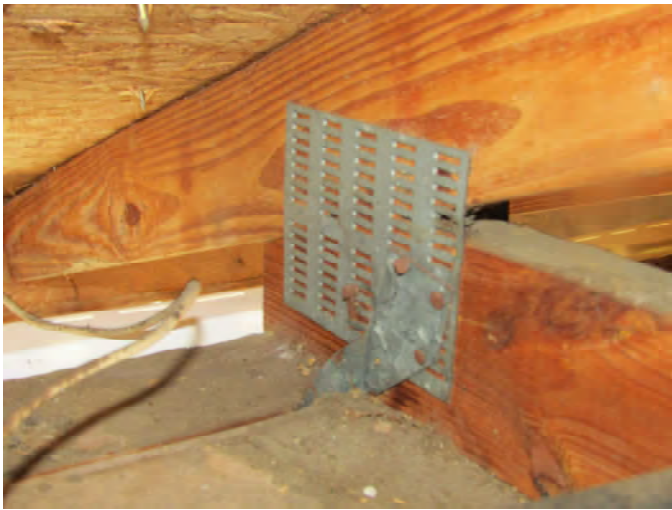
Clip

- ☒ Secured to truss/rafter with a minimum of three (3) nails, **and**
- ☒ Attached to the wall top plate of the wall framing, or embedded in the bond beam, with less than a 1/2" gap from the blocking or truss/rafter **and** blocked no more than 1.5" of the truss/rafter, **and** free of visible severe corrosion.
- ☒ B. Clips
  - ☒ Metal connectors that do not wrap over the top of the truss/rafter, **or**
  - ☐ Metal connectors with a minimum of 1 strap that wraps over the top of the truss/rafter and does not meet the nail position requirements of C or D, but is secured with a minimum of 3 nails.
- ☐ C. Single Wraps

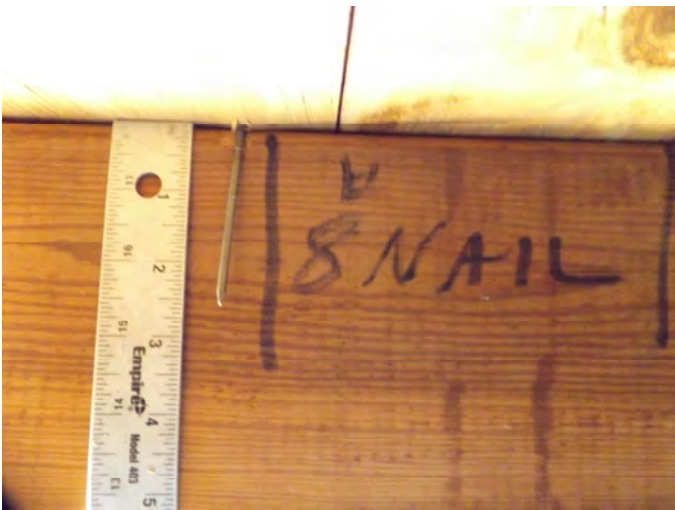
Nail Lenght

- ☒ C. Plywood/OSB roof sheathing with a minimum thickness of 7/16" inch attached to the roof truss/rafter (spaced a maximum of 24" inches o.c.) by 8d common nails spaced a maximum of 6" inches in the field. -OR- Dimensional lumber/Tongue & Groove decking with a minimum of 2 nails per board (or 1 nail per board if each board is equal to or less than 6 inches in width). -OR-

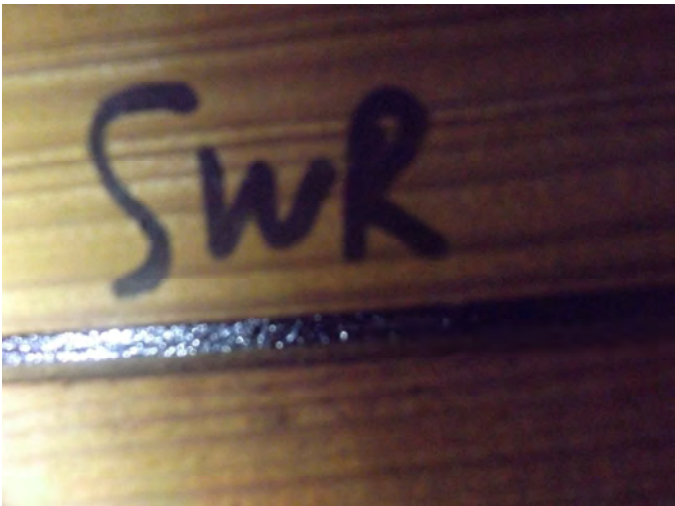
- ☒ A. SWR (also called Sealed Roof Deck) Self-adhering polymer modified-bitumen roofing underlayment applied directly to the sheathing or foam adhesive SWR barrier (not foamed-on insulation) applied as a supplemental means to protect the dwelling from water intrusion in the event of roof covering loss.
- ☐ B. No SWR.
- ☐ C. Unknown or undetermined.
