# Uniform Mitigation Verification Inspection Form

| Inspection Date: 05/14/2025 | | |
| Owner Name: Pinewood Village | | Contact Person: |
| Address: 601 N. Hercules Ave Bldg. 4 | | Home Phone: |

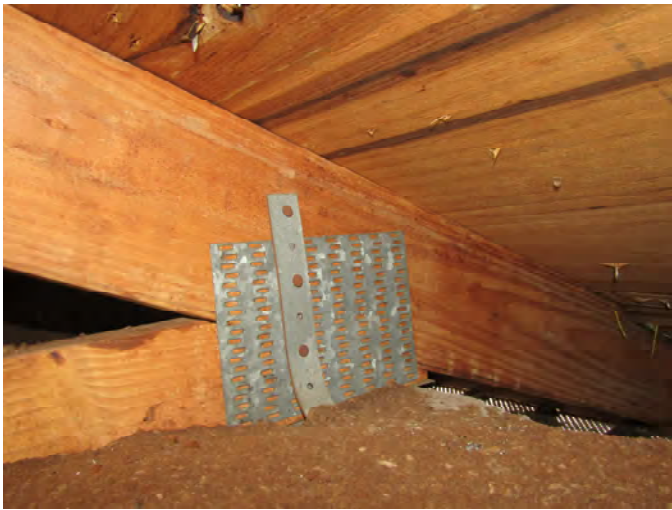
- ☒ Secured to truss/rafter with a minimum of three (3) nails, **and**
- ☒ Attached to the wall top plate of the wall framing, or embedded in the bond beam, with less than a 1/2" gap from the blocking or truss/rafter **and** blocked no more than 1.5" of the truss/rafter, **and** free of visible severe corrosion.
- ☒ B. Clips
  - ☒ Metal connectors that do not wrap over the top of the truss/rafter, **or**
  - ☐ Metal connectors with a minimum of 1 strap that wraps over the top of the truss/rafter and does not meet the nail position requirements of C or D, but is secured with a minimum of 3 nails.
- ☐ C. Single Wraps

Clip

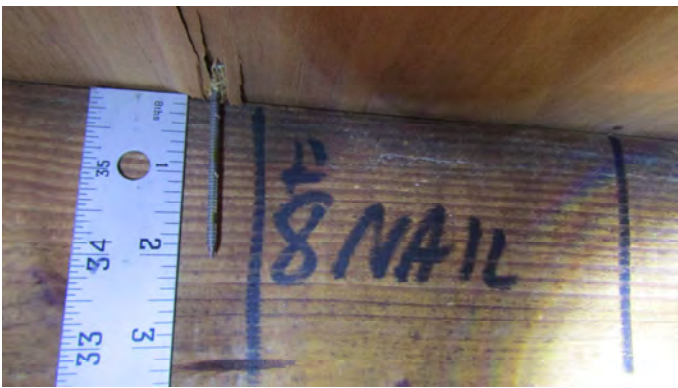
- ☒ C. Plywood/OSB roof sheathing with a minimum thickness of 7/16" inch attached to the roof truss/rafter (spaced a maximum of 24" inches o.c.) by 8d common nails spaced a maximum of 6" inches in the field. -OR- Dimensional lumber/Tongue & Groove decking with a minimum of 2 nails per board (or 1 nail per board if each board is equal to or less than 6 inches in width). -OR-

Nail Length

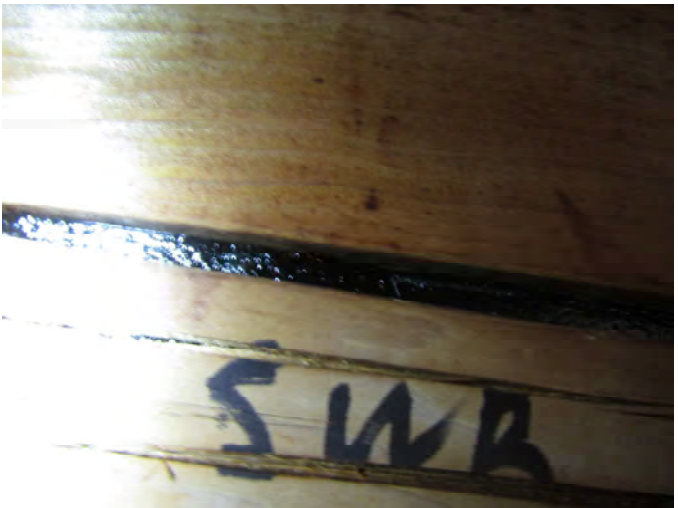
- ☒ A. SWR (also called Sealed Roof Deck) Self-adhering polymer modified-bitumen roofing underlayment applied directly to the sheathing or foam adhesive SWR barrier (not foamed-on insulation) applied as a supplemental means to protect the dwelling from water intrusion in the event of roof covering loss.
- ☐ B. No SWR.
- ☐ C. Unknown or undetermined.

SWR
