# Uniform Mitigation Verification Inspection Form

| Owner Name: Pinewood Village Bldg. 5 | | Contact Person: |
| Address: 601 No. Hercules Ave | | Home Phone: |

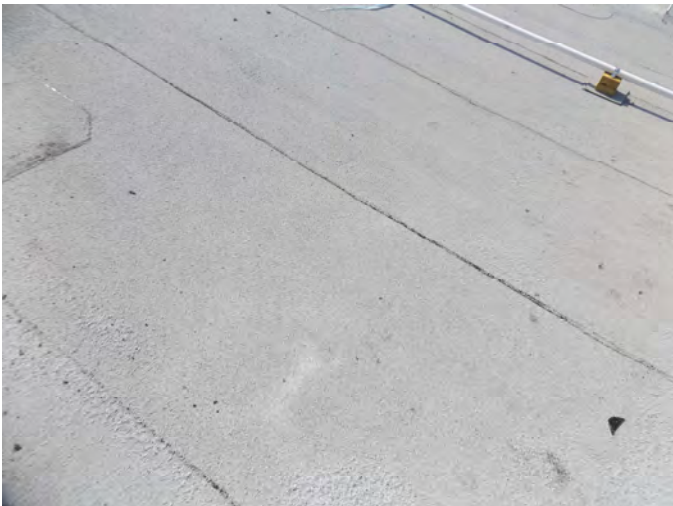
Roof - 1

| 2.1 Roof Covering Type: | Permit Application Date | FBC or MDC Product Approval # | Year of Original Installation or Replacement | No Information Provided for Compliance |
|---|---|---|---|---|
| <input checked="" type="checkbox"/> 5. Membrane | 03/16/2021 | | 2021 | <input type="checkbox"/> |

- ☐ A. Hip Roof      Hip roof with no other roof shapes greater than 10% of the total roof system perimeter.  
Total length of non-hip features: \_\_\_\_\_ feet; Total roof system perimeter: \_\_\_\_\_ feet
- ☒ B. Flat Roof      Roof on a building with 5 or more units where at least 90% of the main roof area has a roof slope of less than 2:12. Roof area with slope less than 2:12      sq ft; Total roof area      sq ft
- ☐ C. Other Roof      Any roof that does not qualify as either (A) or (B) above.

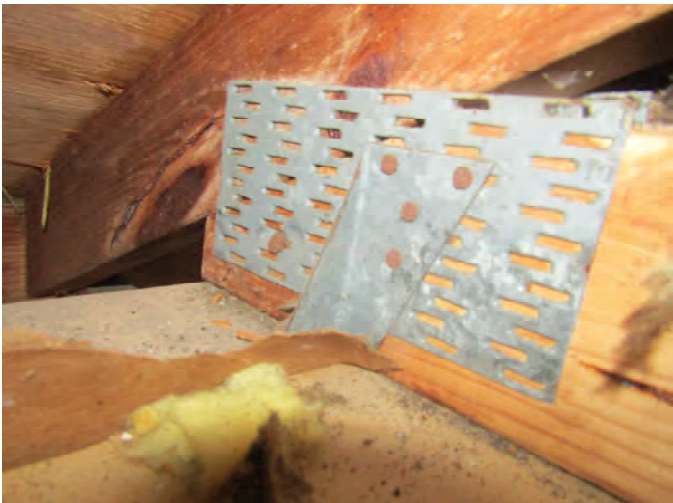
Clip

- ☒ Secured to truss/rafter with a minimum of three (3) nails, **and**
- ☒ Attached to the wall top plate of the wall framing, or embedded in the bond beam, with less than a 1/2" gap from the blocking or truss/rafter **and** blocked no more than 1.5" of the truss/rafter, **and** free of visible severe corrosion.
- ☒ B. Clips
  - ☒ Metal connectors that do not wrap over the top of the truss/rafter, **or**
  - ☐ Metal connectors with a minimum of 1 strap that wraps over the top of the truss/rafter and does not meet the nail position requirements of C or D, but is secured with a minimum of 3 nails.
- ☐ C. Single Wraps

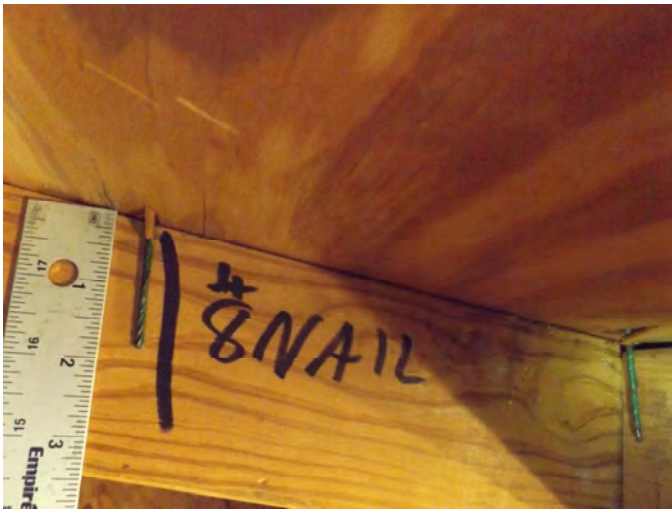
Nail length

- ☒ C. Plywood/OSB roof sheathing with a minimum thickness of 7/16" inch attached to the roof truss/rafter (spaced a maximum of 24" inches o.c.) by 8d common nails spaced a maximum of 6" inches in the field. -OR- Dimensional lumber/Tongue & Groove decking with a minimum of 2 nails per board (or 1 nail per board if each board is equal to or less than 6 inches in width). -OR-

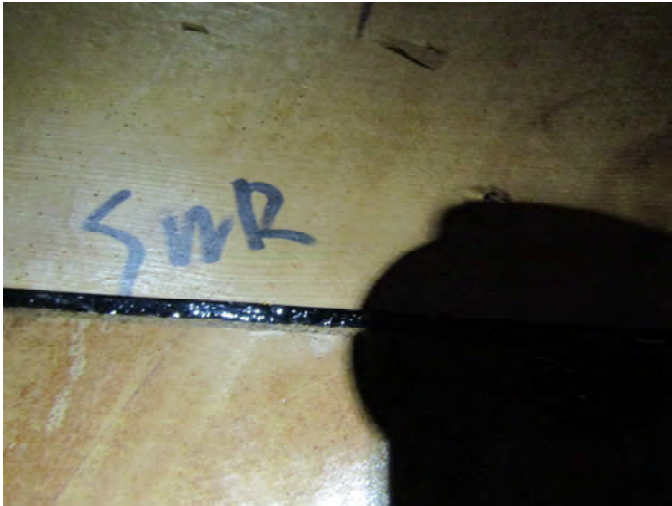
- ☒ A. SWR (also called Sealed Roof Deck) Self-adhering polymer modified-bitumen roofing underlayment applied directly to the sheathing or foam adhesive SWR barrier (not foamed-on insulation) applied as a supplemental means to protect the dwelling from water intrusion in the event of roof covering loss.
- ☐ B. No SWR.
- ☐ C. Unknown or undetermined.
