# Uniform Mitigation Verification Inspection Form

| Inspection Date: 05/15/2025 | | |
| Owner Name: Pinewood Village Condo's | | Contact Person: |
| Address: 601 N. Hercules Ave. Bldg. 6 | | Home Phone: |

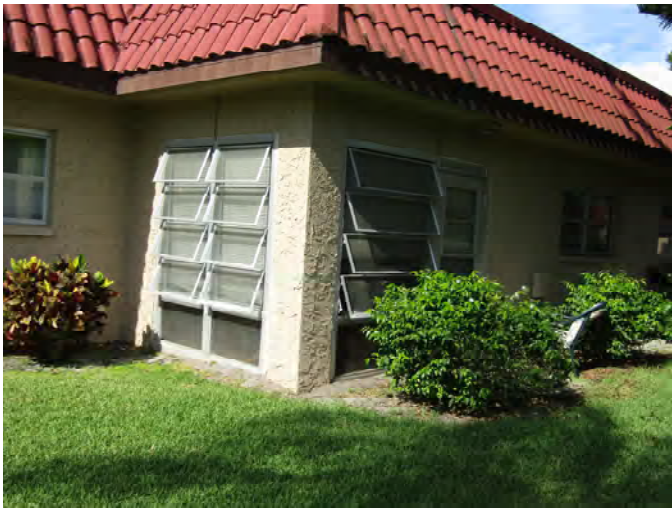
| Opening Protection Level Chart<br>Place an "X" in each row to identify all forms of protection in use for each opening type. Check only one answer below (A thru X), based on the weakest form of protection (lowest row) for any of the Glazed openings and indicate the weakest form of protection (lowest row) for Non-Glazed openings. | | Glazed Openings | | | | Non-Glazed Openings | |
|---|---|---|---|---|---|---|---|
| X | No Windborne Debris Protection | X | | | | X | X |

No window or door protection

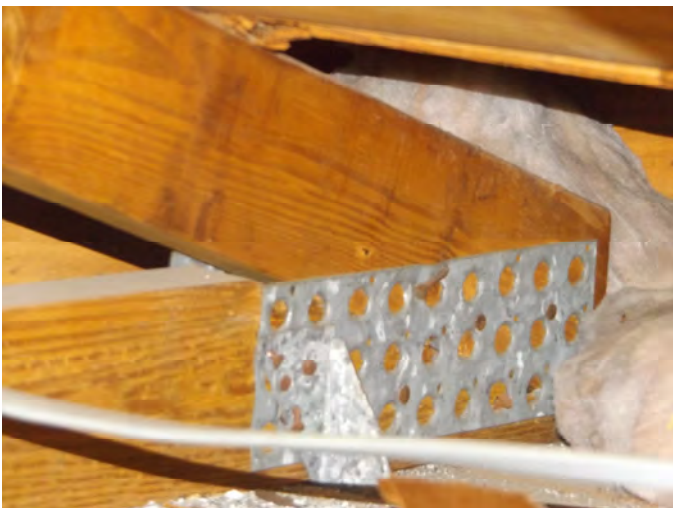
- ☒ Secured to truss/rafter with a minimum of three (3) nails, **and**
- ☒ Attached to the wall top plate of the wall framing, or embedded in the bond beam, with less than a 1/2" gap from the blocking or truss/rafter **and** blocked no more than 1.5" of the truss/rafter, **and** free of visible severe corrosion.
- ☒ B. Clips
  - ☒ Metal connectors that do not wrap over the top of the truss/rafter, **or**
  - ☐ Metal connectors with a minimum of 1 strap that wraps over the top of the truss/rafter and does not meet the nail position requirements of C or D, but is secured with a minimum of 3 nails.
- ☐ C. Single Wraps

Clip

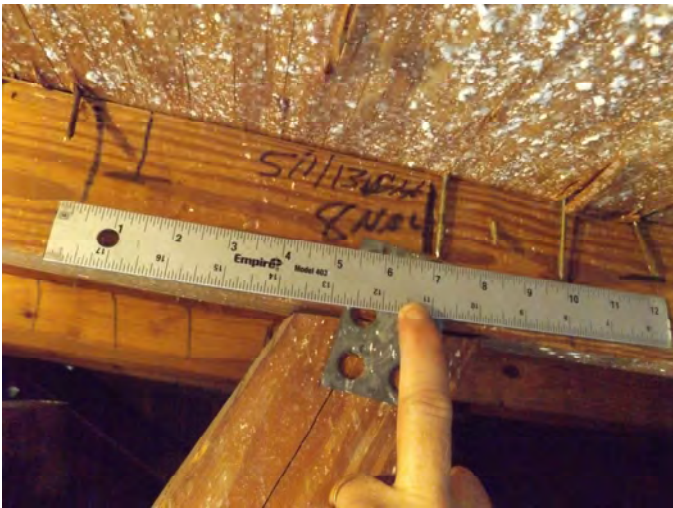
- ☒ C. Plywood/OSB roof sheathing with a minimum thickness of 7/16" inch attached to the roof truss/rafter (spaced a maximum of 24" inches o.c.) by 8d common nails spaced a maximum of 6" inches in the field. -OR- Dimensional lumber/Tongue & Groove decking with a minimum of 2 nails per board (or 1 nail per board if each board is equal to or less than 6 inches in width). -OR-

Nail spacing - 1

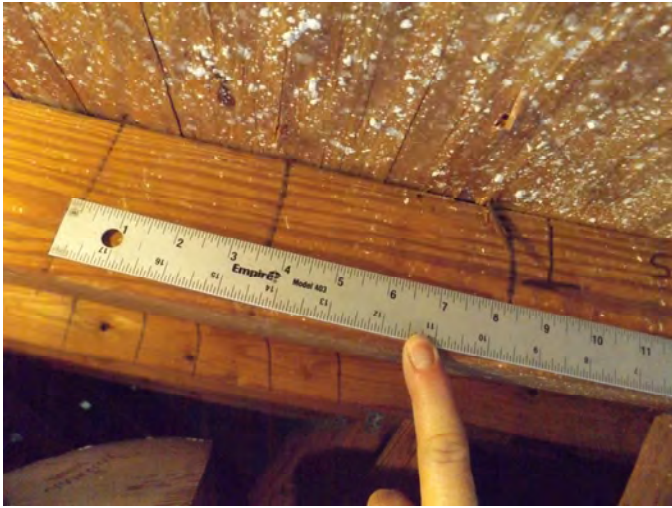
Nail spacing - 2

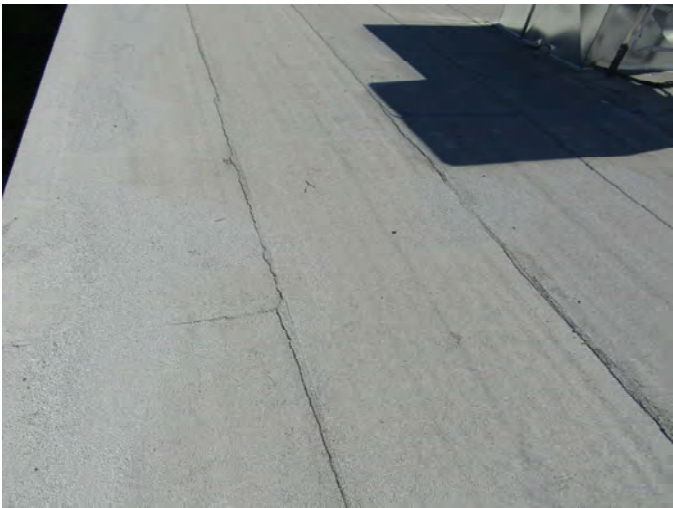
Roof - 1

| 2.1 Roof Covering Type: | Permit Application Date | FBC or MDC Product Approval # | Year of Original Installation or Replacement | No Information Provided for Compliance |
|---|---|---|---|---|
| <input checked="" type="checkbox"/> 5. Membrane | 3 - 10 - 2020 | | 2020 | <input type="checkbox"/> |

- ☐ A. Hip Roof      Hip roof with no other roof shapes greater than 10% of the total roof system perimeter.  
Total length of non-hip features: \_\_\_\_\_ feet; Total roof system perimeter: \_\_\_\_\_ feet
- ☒ B. Flat Roof      Roof on a building with 5 or more units where at least 90% of the main roof area has a roof slope of less than 2:12. Roof area with slope less than 2:12      sq ft; Total roof area      sq ft
- ☐ C. Other Roof      Any roof that does not qualify as either (A) or (B) above.
