Uniform Mitigation Verification Inspection Form

Inspection Date: 04/15/2025		
Owner Information		
Owner Name: Pinewood Village Condo's		Contact Person:
Address: 601 N. Hercules Ave. Bldg. 7		Home Phone:
City: Clearwater	Zip: 33765	Work Phone:
County: Pinellas		Cell Phone:
Insurance Company:		Policy #:
Year of Home: 1978	# of Stories: 1	Email:

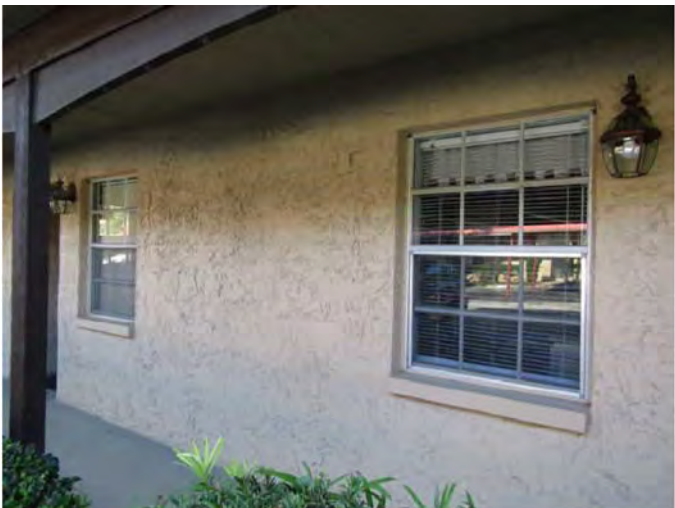
N	Opening Protection products that appear to be A or B but are not verified						
	Other protective coverings that cannot be identified as A, B, or C						
X	No Windborne Debris Protection	X				X

No window or door protection

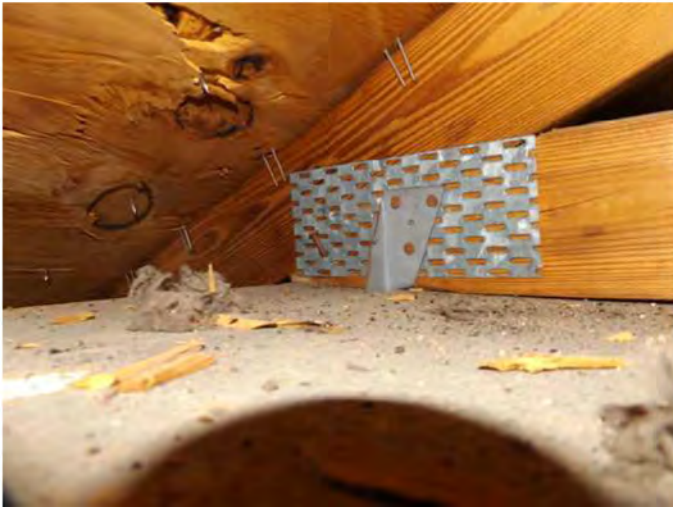
- ☒ Secured to truss/rafter with a minimum of three (3) nails, **and**
- ☒ Attached to the wall top plate of the wall framing, or embedded in the bond beam, with less than a 1/2" gap from the blocking or truss/rafter **and** blocked no more than 1.5" of the truss/rafter, **and** free of visible severe corrosion.
- ☒ B. Clips
 - ☒ Metal connectors that do not wrap over the top of the truss/rafter, **or**
 - ☐ Metal connectors with a minimum of 1 strap that wraps over the top of the truss/rafter and does not meet the nail position requirements of C or D, but is secured with a minimum of 3 nails.
- ☐ C. Single Wraps

Clip

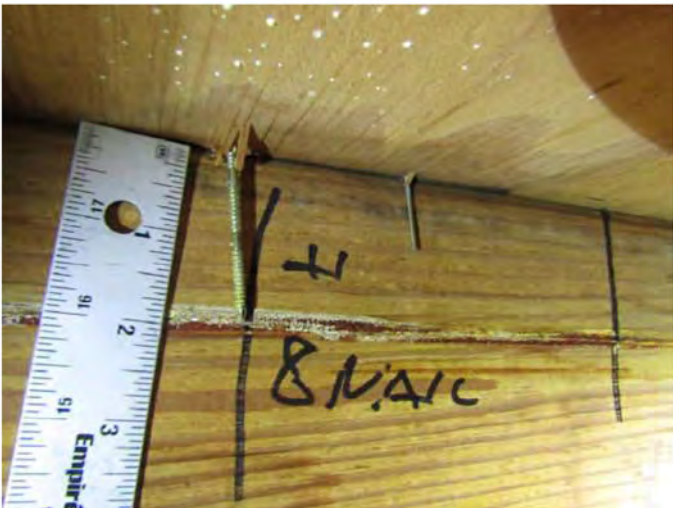
- ☒ C. Plywood/OSB roof sheathing with a minimum thickness of 7/16" inch attached to the roof truss/rafter (spaced a maximum of 24" inches o.c.) by 8d common nails spaced a maximum of 6" inches in the field. -OR- Dimensional lumber/Tongue & Groove decking with a minimum of 2 nails per board (or 1 nail per board if each board is equal to or less than 6 inches in width). -

Nail length

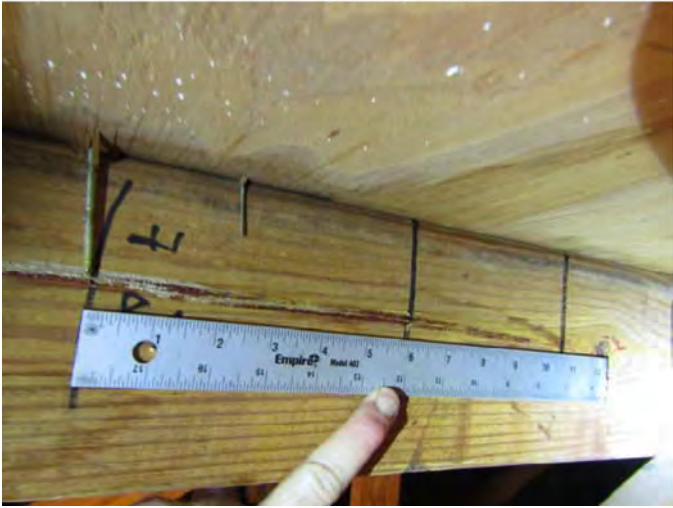
Nail spacing - 1

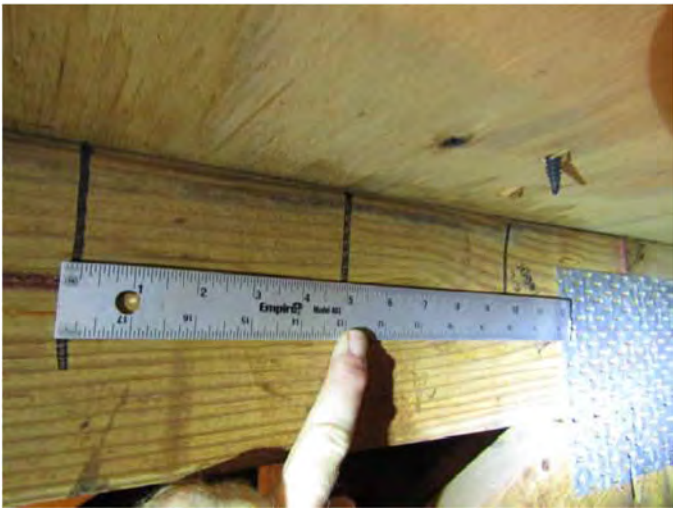
Nail spacing - 2

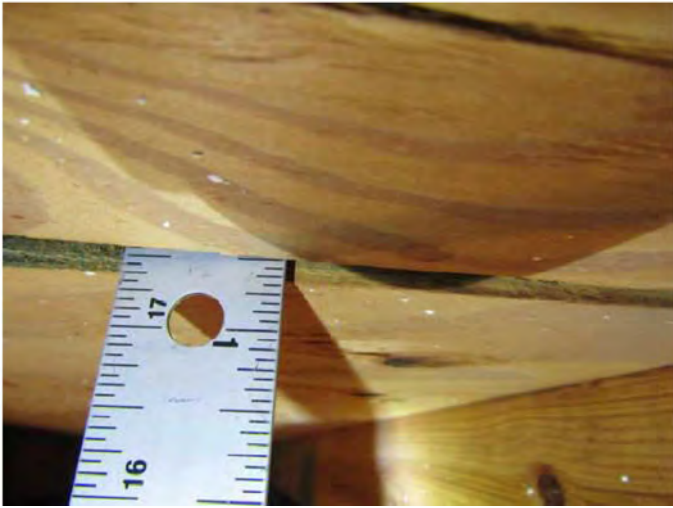
Plywood width

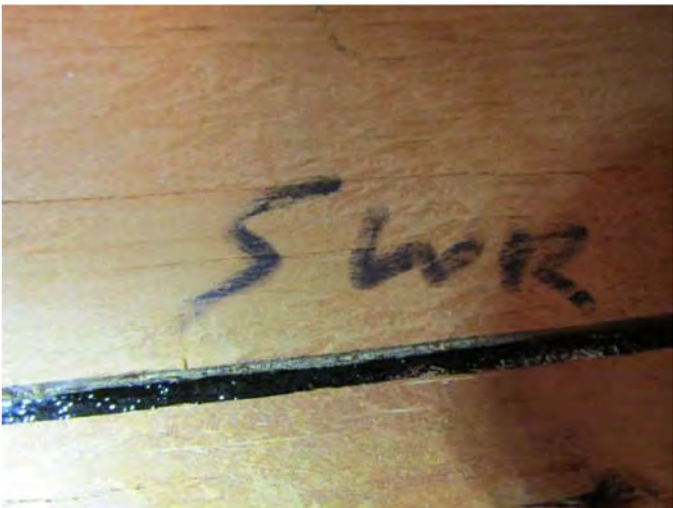
- ☒ A. SWR (also called Sealed Roof Deck) Self-adhering polymer modified-bitumen roofing underlayment applied directly to the sheathing or foam adhesive SWR barrier (not foamed-on insulation) applied as a supplemental means to protect the dwelling from water intrusion in the event of roof covering loss.
- ☐ B. No SWR.
- ☐ C. Unknown or undetermined.

SWR
