# Uniform Mitigation Verification Inspection Form

| Inspection Date: 05/15/2025 | | |
| Owner Name: Pinewood Village Bldg. 8 | | Contact Person: |
| Address: 601 N. Hercules Ave | | Home Phone: |

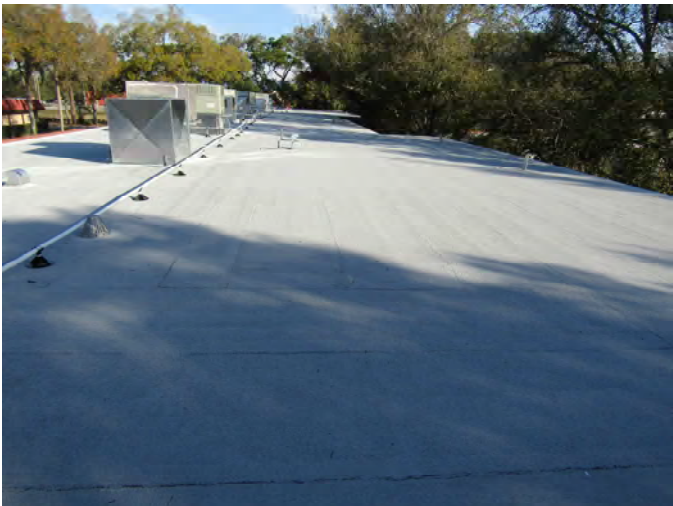
Roof - 1

| 2.1 Roof Covering Type: | Permit Application Date | FBC or MDC Product Approval # | Year of Original Installation or Replacement | No Information Provided for Compliance |
|---|---|---|---|---|
| <input checked="" type="checkbox"/> 5. Membrane | 12/16/2021 | | 2021 | <input type="checkbox"/> |

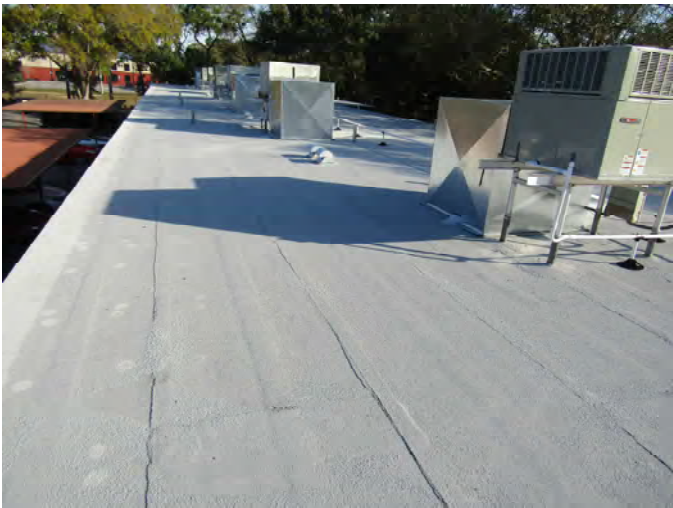
Roof - 3

- ☐ A. Hip Roof      Hip roof with no other roof shapes greater than 10% of the total roof system perimeter.  
Total length of non-hip features: \_\_\_\_\_ feet; Total roof system perimeter: \_\_\_\_\_ feet
- ☒ B. Flat Roof      Roof on a building with 5 or more units where at least 90% of the main roof area has a roof slope of less than 2:12. Roof area with slope less than 2:12      sq ft; Total roof area      sq ft
- ☐ C. Other Roof      Any roof that does not qualify as either (A) or (B) above.

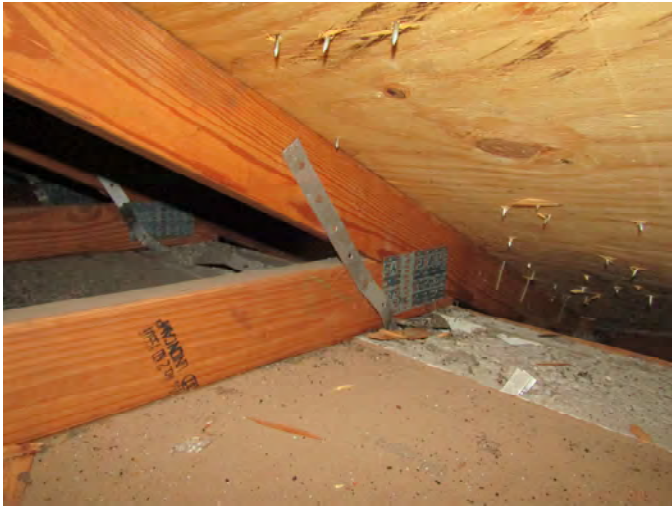
- ☒ Secured to truss/rafter with a minimum of three (3) nails, **and**
- ☒ Attached to the wall top plate of the wall framing, or embedded in the bond beam, with less than a 1/2" gap from the blocking or truss/rafter **and** blocked no more than 1.5" of the truss/rafter, **and** free of visible severe corrosion.
- ☒ B. Clips
  - ☒ Metal connectors that do not wrap over the top of the truss/rafter, **or**
  - ☐ Metal connectors with a minimum of 1 strap that wraps over the top of the truss/rafter and does not meet the nail position requirements of C or D, but is secured with a minimum of 3 nails.
- ☐ C. Single Wraps

Clip

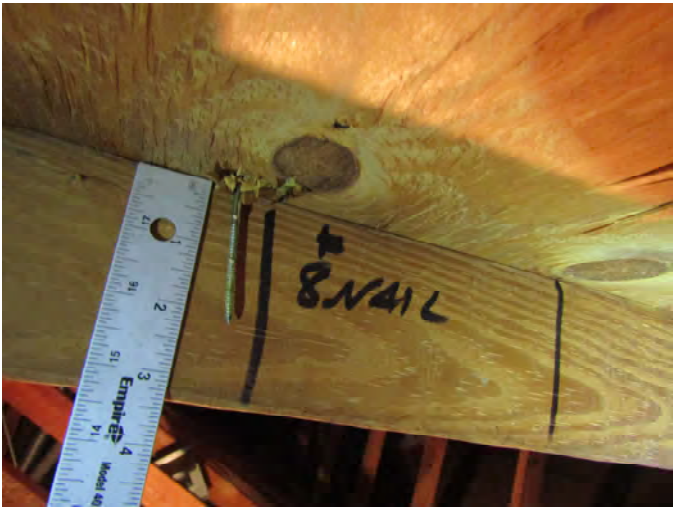
- ☒ C. Plywood/OSB roof sheathing with a minimum thickness of 7/16" inch attached to the roof truss/rafter (spaced a maximum of 24" inches o.c.) by 8d common nails spaced a maximum of 6" inches in the field. -OR- Dimensional lumber/Tongue & Groove decking with a minimum of 2 nails per board (or 1 nail per board if each board is equal to or less than 6 inches in width). -OR-

Nail length

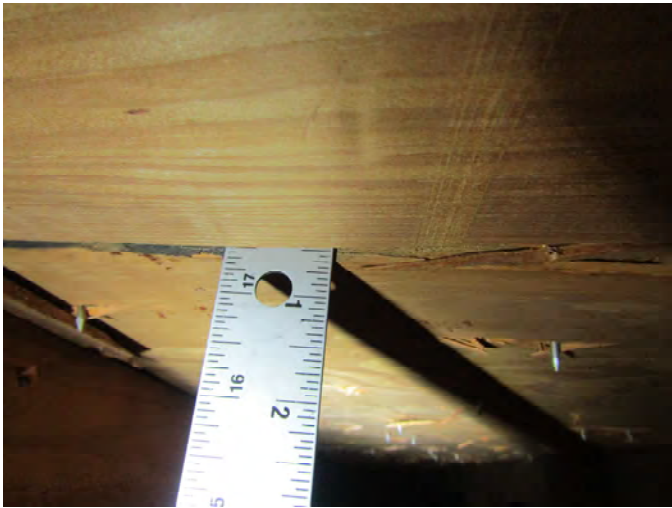
Plywood width

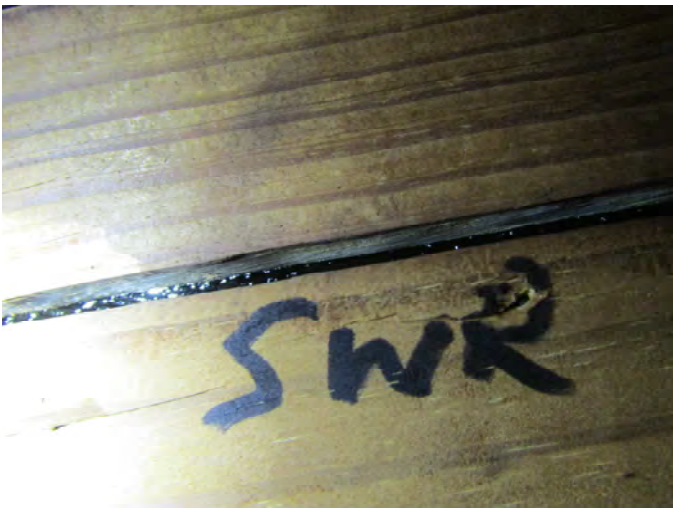
- ☒ A. SWR (also called Sealed Roof Deck) Self-adhering polymer modified-bitumen roofing underlayment applied directly to the sheathing or foam adhesive SWR barrier (not foamed-on insulation) applied as a supplemental means to protect the dwelling from water intrusion in the event of roof covering loss.
- ☐ B. No SWR.
- ☐ C. Unknown or undetermined.

SWR
