# Uniform Mitigation Verification Inspection Form

| Inspection Date: 05/17/2025 | | |
| Owner Name: Pinewood Village Bldg. 9 | | Contact Person: |
| Address: 601 N. Hercules Ave | | Home Phone: |

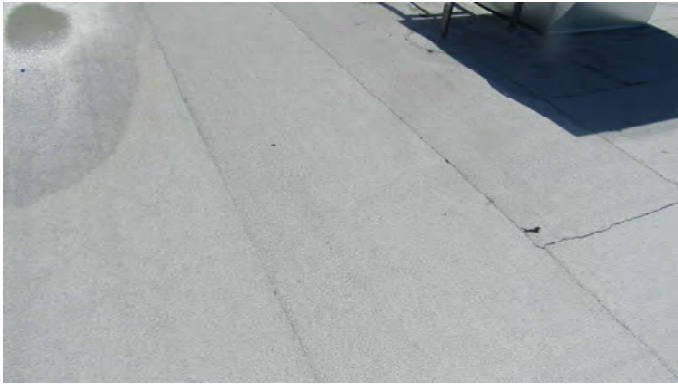
Roof - 1

| 2.1 Roof Covering Type: | Permit Application Date | FBC or MDC Product Approval # | Year of Original Installation or Replacement | No Information Provided for Compliance |
|---|---|---|---|---|
| <input checked="" type="checkbox"/> 5. Membrane | 04/28/2021 | | 2021 | <input type="checkbox"/> |

- ☐ A. Hip Roof      Hip roof with no other roof shapes greater than 10% of the total roof system perimeter.  
Total length of non-hip features: \_\_\_\_\_ feet; Total roof system perimeter: \_\_\_\_\_ feet
- ☒ B. Flat Roof      Roof on a building with 5 or more units where at least 90% of the main roof area has a roof slope of less than 2:12. Roof area with slope less than 2:12      sq ft; Total roof area      sq ft
- ☐ C. Other Roof      Any roof that does not qualify as either (A) or (B) above.

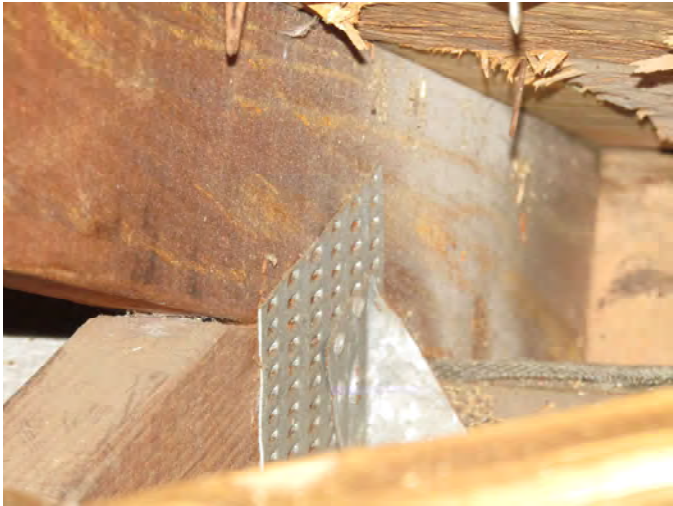
- ☒ Secured to truss/rafter with a minimum of three (3) nails, **and**
- ☒ Attached to the wall top plate of the wall framing, or embedded in the bond beam, with less than a 1/2" gap from the blocking or truss/rafter **and** blocked no more than 1.5" of the truss/rafter, **and** free of visible severe corrosion.
- ☒ B. Clips
  - ☒ Metal connectors that do not wrap over the top of the truss/rafter, **or**
  - ☐ Metal connectors with a minimum of 1 strap that wraps over the top of the truss/rafter and does not meet the nail position requirements of C or D, but is secured with a minimum of 3 nails.
- ☐ C. Single Wraps

Clip

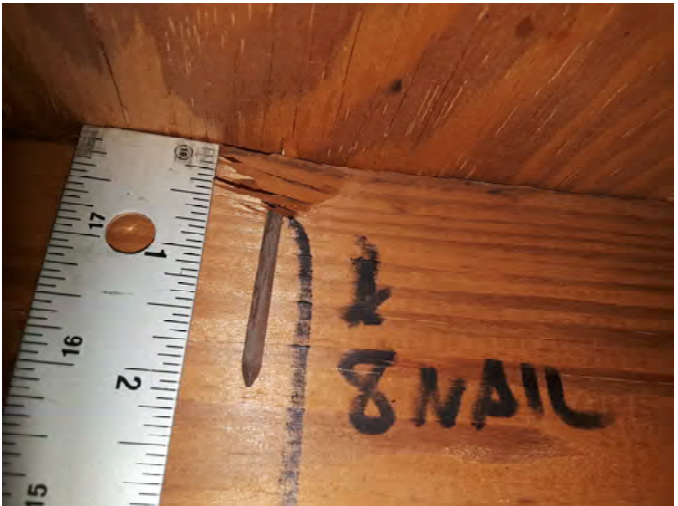
- ☒ C. Plywood/OSB roof sheathing with a minimum thickness of 7/16" inch attached to the roof truss/rafter (spaced a maximum of 24" inches o.c.) by 8d common nails spaced a maximum of 6" inches in the field. -OR- Dimensional lumber/Tongue & Groove decking with a minimum of 2 nails per board (or 1 nail per board if each board is equal to or less than 6 inches in width). -OR-

Nail length

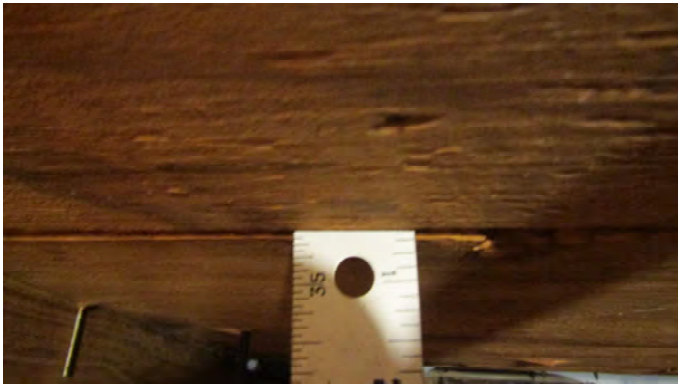
Width

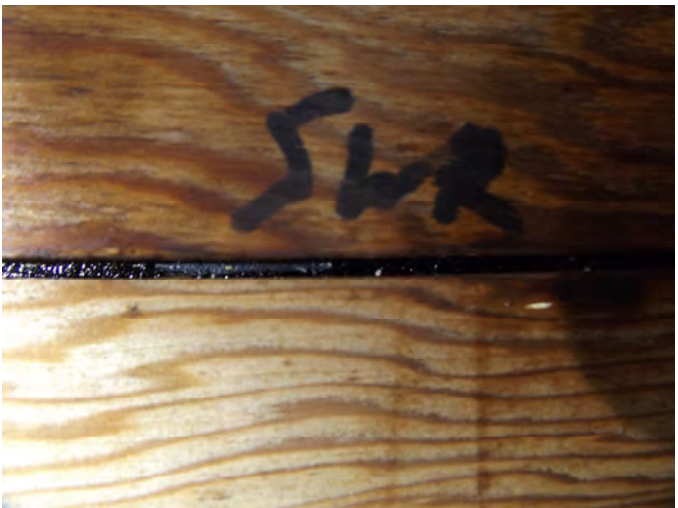
- ☒ A. SWR (also called Sealed Roof Deck) Self-adhering polymer modified-bitumen roofing underlayment applied directly to the sheathing or foam adhesive SWR barrier (not foamed-on insulation) applied as a supplemental means to protect the dwelling from water intrusion in the event of roof covering loss.
- ☐ B. No SWR.
- ☐ C. Unknown or undetermined.

SWR
